## CYPRESS POINT ABC STRATA PLAN NW2050

# MAINTENANCE: BUILDING INSPECTION REPORT SATURDAY, APRIL 29, 2006

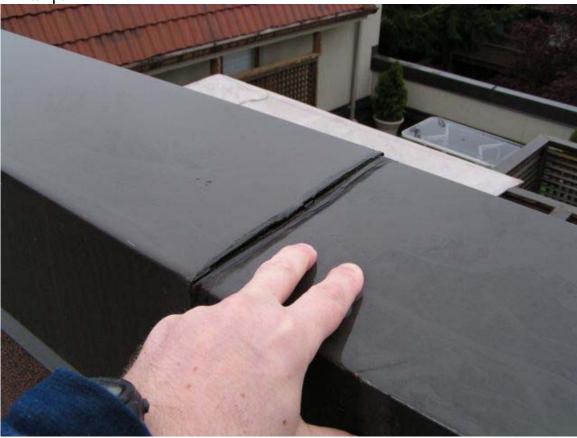
## a. Roof Calking

As per standard building practices, there is calking on the joints between sections of flashing on the roof. General improvement over last year was noted, however, some of the calking between these joints has again cracked.

It was agreed by the committee to recommend the reinforcement and/or replacement of the calking on the defective joints. Perhaps a larger 'bead' of calking is required on the roof flashing, since the metal-to-metal joints are probably subject to flexing as the sun heats them up.

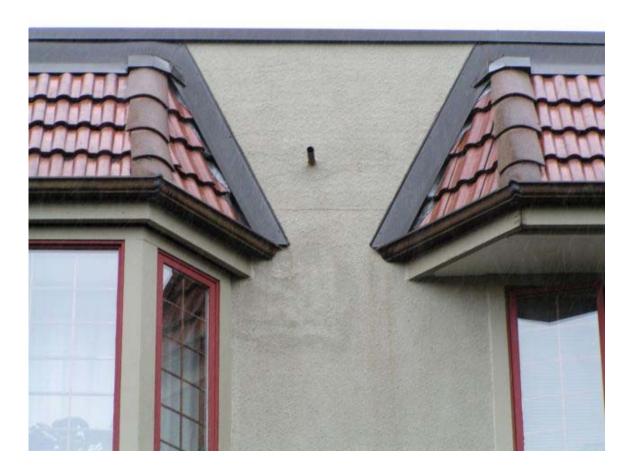
## b. Blistering Stucco

Between 330/329 windows, a patch of uneven stucco was noticed.
