Building Enclosure Condition Assessment

Cypress Point

7511, 7531 & 7651 Minoru Boulevard, Richmond, BC

RJC No. VAN.037207.0029

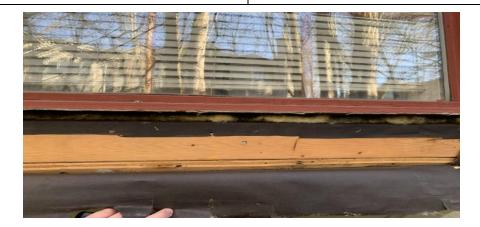
- Exterior wood trim removed under middle (west facing) window sill
- No deterioration observed on interior wood framing
- Staining of fibreglass insulation observed

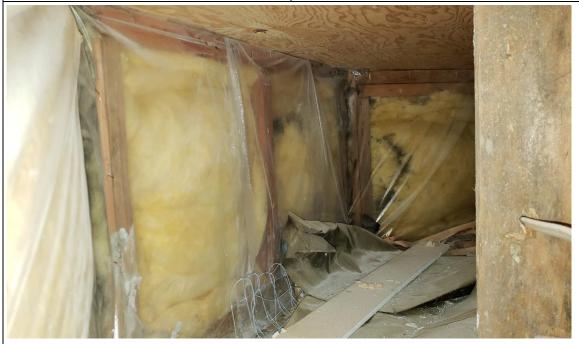
Interior Recess 2 (IR-02)					
Location	Wall Type	Moisture Content (MC) of Wall Components	Deterioration Scale	Interior Conditions	
Unit 318 Bldg B Bedroom North Elevation	Wood Cladding, Batt Insulation on 2x4 Wood Framing	Exterior: Dry (D-Fir), Wood Framing Exterior: 8% MC (D-Fir), Plywood Interior: 0.1% MC (GWB)	1	T: 22ºC* RH: 61%**

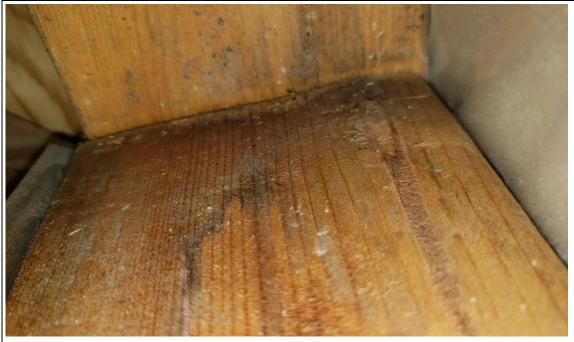
Interior Recess 3 (IR-03)						
Location	Wall Type	Moisture Content (MC) of Wall Components	Deterioration Scale	Interior Conditions		
Unit 322 Bldg B Bedroom Northwest Corner	Wood Cladding, Batt Insulation on 2x4 Wood Framing	Exterior: Dry (D-Fir), Wood Framing Exterior: Dry (D-Fir), Plywood Interior: 0.2% MC (GWB)	1	T: 22ºC* RH: 61%**

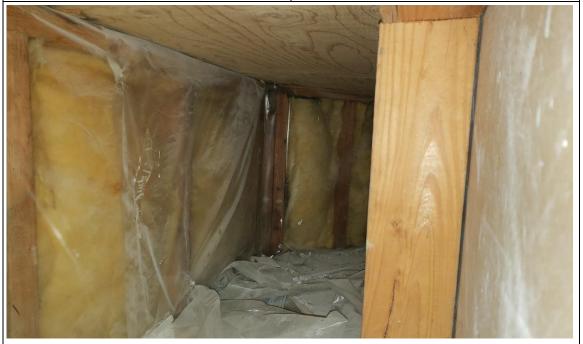
Interior Recess 4 (IR-04)					
Location	Wall Type	Moisture Content (MC) of Wall Components	Deterioration Scale	Interior Conditions	
Unit 313 Bldg B Living Room North Elevation	Wood Cladding, Batt Insulation on 2x4 Wood Framing	Exterior: 7% MC (D-Fir), Wood Framing Exterior: 8% MC (D-Fir), Plywood Interior: 0.1% MC (GWB)	1	T: 22ºC* RH: 61%**

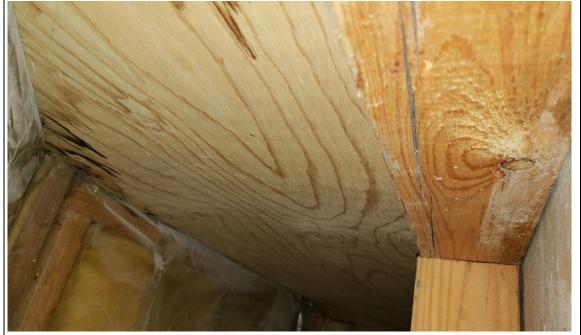
Interior Recess 5 (II	Interior Recess 5 (IR-05)					
Location	Wall Type	Moisture Content (MC) of Wall Components	Deterioration Scale	Interior Conditions		
Unit 222 Bldg B Living Room Northwest Corner	Wood Cladding, Batt Insulation on 2x4 Wood Framing	Exterior: Dry (D-Fir), Wood Framing Exterior: Dry (D-Fir), Plywood Interior: 0.2% MC (GWB)	1	T: 22ºC* RH: 61%**

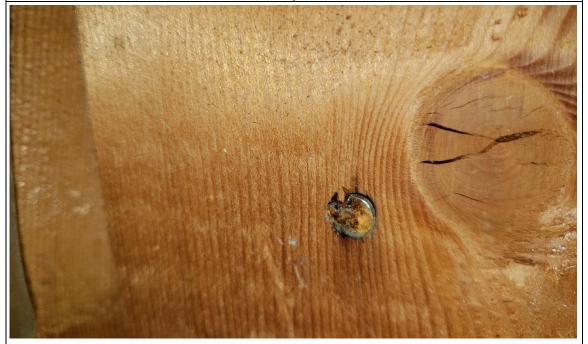
Interior Recess 6 (II	Interior Recess 6 (IR-06)					
Location	Wall Type	Moisture Content (MC) of Wall Components	Deterioration Scale	Interior Conditions		
Unit 120 Bldg B Living Room East Elevation	Stucco Cladding, Batt Insulation on 2x4 Wood Framing	Exterior: Dry (D-Fir), Wood Framing Exterior: Dry (D-Fir), Plywood Interior: 0.1% MC (GWB)	0	T: 22ºC* RH: 61%**

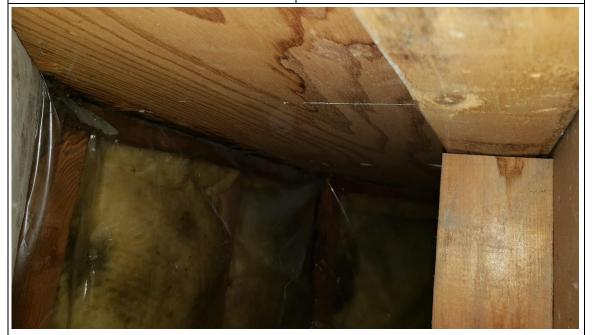
Interior Recess 7 (IR-07)					
Location	Wall Type	Moisture Content (MC) of Wall Components	Deterioration Scale	Interior Conditions	
Unit 336 Bldg C Kitchen South Elevation	Wood Cladding, Batt Insulation on 2x4 Wood Framing	Exterior: 8% MC (D-Fir), Wood Framing Exterior: Dry (D-Fir), Plywood Interior: 0.1% MC (GWB)	1	T: 22ºC* RH: 61%**

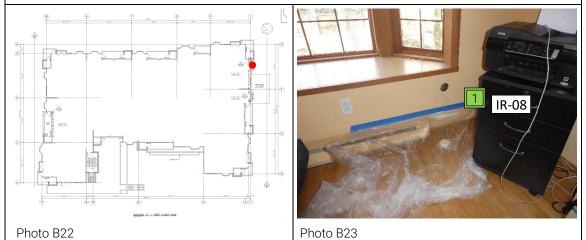
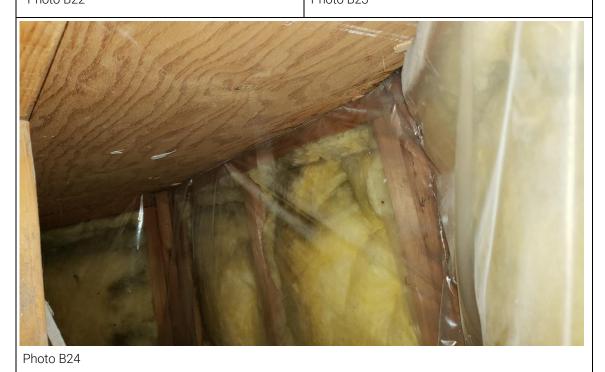
Interior Recess 8 (IF	Interior Recess 8 (IR-08)					
Location	Wall Type	Moisture Content (MC) of Wall Components	Deterioration Scale	Interior Conditions		
Unit 330 Bldg C Bedroom North Elevation	Wood Cladding, Batt Insulation on 2x4 Wood Framing	Exterior: Dry (D-Fir), Wood Framing Exterior: Dry (D-Fir), Plywood Interior: 0.2% MC (GWB)	1	T: 22ºC* RH: 61%**

- Opening made below the sill and adjacent to the mullion of the bay window.
- Minor staining observed on paper batt insulation and wood stud framing.

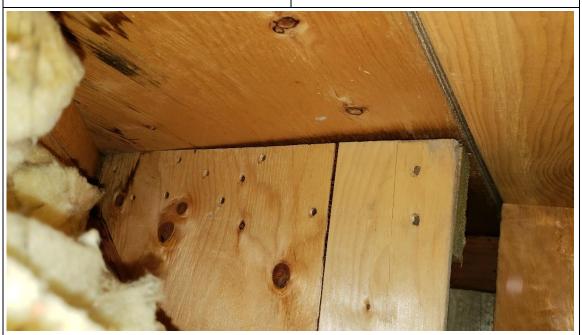
Interior Recess 9 (IR-09)					
Location	Wall Type	Moisture Content (MC) of Wall Components	Deterioration Scale	Interior Conditions	
Unit 138 Bldg C Bedroom South Elevation	Wood Cladding, Batt Insulation on 2x4 Wood Framing	Exterior: 7% MC (D-Fir), Wood Framing Exterior: 8% MC (D-Fir), Plywood Interior: 0.1% MC (GWB)	1	T: 22ºC* RH: 61%**
