R-02574.062 Cypress Point | Roof Assessment

REGARDING Roof Assessment

As requested by the Owners, Strata Plan NW2050 (Owners), RDH Building Science Inc. (RDH) is pleased to provide you with this report for a roof assessment for the complex known as Cypress Point, located at 7511, 7531, and 7651 Minoru Boulevard, Richmond, BC.

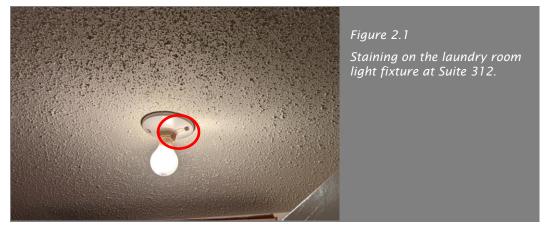
At Suite 312, there was some staining on the ceiling light fixture in the laundry room (Figure 2.1). It is our understanding that water ingress had occurred a few times during rain events beginning in late 2021. The area was dry at the time of the review.

The owners/residents at Suites 312 and 322 should continue to monitor for water ingress, document, and report any changes.

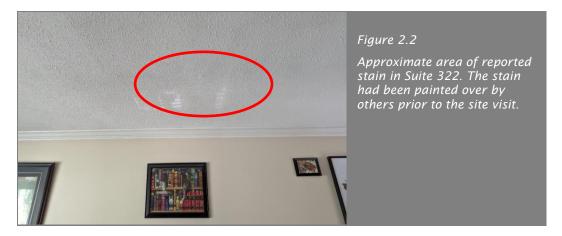
At Suite 322, the suite owner indicated that there was staining on the living room ceiling that appeared in approximately 2015. The owner indicated that the stain grew in size until repairs were reported to have been implemented in late 2021. The ceiling was also repainted in 2021. At the time of the review, there was minimal evidence of staining (Figure 2.2).

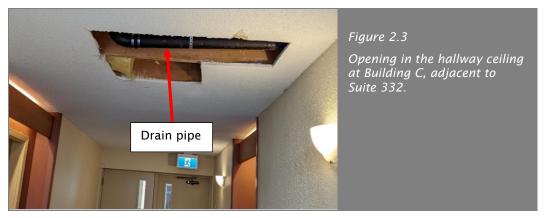
In the hallway of Building C, adjacent to Suite 332, a localized section of ceiling drywall (GWB) was removed by others prior to the site visit, exposing the underside of a roof drain assembly (Figure 2.3). We were informed by the Strata Office Administrator that the drain pipe connected to a roof drain had leaked at a plumbing joint. It is our understanding that a plumbing contractor was retained to repair the leak. The area was dry at the time of the review. It is our understanding that the issue was unrelated to water ingress through the roof assembly.

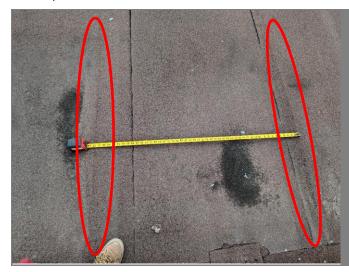
→ There were numerous localized areas of buckling in the SBS membrane (Figure 2.4 to Figure 2.6). At the areas reviewed, the buckling appeared to be caused by displacement of the substrate.

Figure 2.4
Example of buckling in the SBS membrane.
Building A.

There were numerous areas of localized buckling in the SBS membrane. The buckling appeared to originate from the underlying substrate; however, the cause could not be confirmed without exploratory openings, which would involve removing sections of the

SBS membrane to review underlying conditions. According to Atlas-Apex, who have been maintaining the roofs at Cypress Point, the SBS membrane buckling was first noticed in approximately 2017 and has become more prevalent since then. At the time of the low-slope roof renewal, the cause of the buckling should be reviewed, and appropriate measures implemented to address the issue.

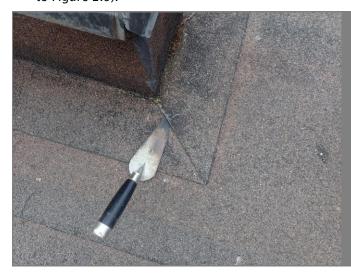
→ There was localized unadhered SBS cap sheet membrane at some locations (Figure 2.7 to Figure 2.9).

Figure 2.7
Example of locally unadhered SBS membrane.
Building A.

In the meantime, and until the low-slope roof renewal is implemented, we recommend that the Owners continue to implement targeted repairs to address failed sealant; localized unadhered SBS membrane; unsealed cracks in the stucco cladding at elevator shaft overruns; and blisters in the SBS membrane. In addition, we recommend that the Owners repair the delaminated liquid-applied membrane at Building B. The Owners should ensure that any repairs are completed in accordance with good roofing practices as outlined by the Roofing Contractors Association of BC (RCABC).

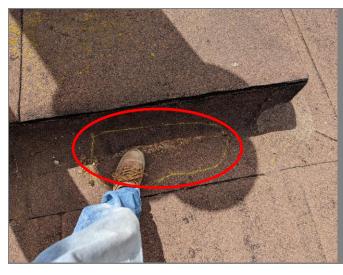
Figure 2.14

\rightarrow There were a few blisters in the SBS membrane at Buildings B and C (Figure 2.13 and Figure 2.14).

Example of a blister in the SBS membrane.

Building C.

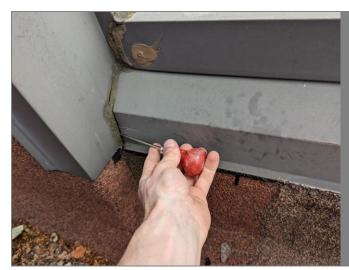
→ There was localized sealant failure at several areas of the metal flashing joints (Figure 2.15 to Figure 2.17).

Figure 2.16
Example of failed sealant at a metal flashing joint.
Building B.

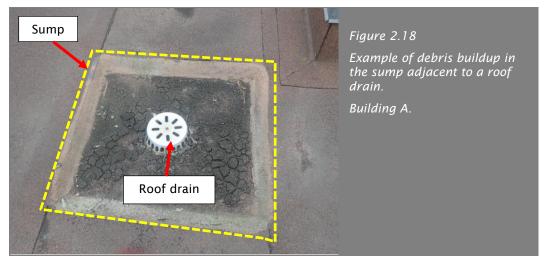
→ There was debris buildup in the sumps adjacent to several of the roof drains (Figure 2.18 to Figure 2.20).

To maximize drainage efficiency, the Owners should clean and remove any debris adjacent to the drains as part of regular strata maintenance activities.

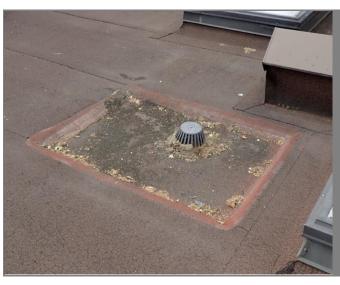
Figure 2.20
Example of debris buildup in the sump adjacent to a roof drain.
Building C.

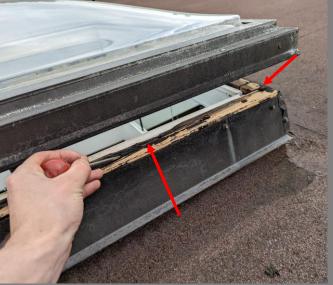
→ A skylight at Building A and one at Building C were partially opened by others at the time of our site visit, likely by the suite residents for ventilation purposes. The underlying assemblies were poorly detailed, partially exposing the wood framing. The exposed wood was stained (Figure 2.24 and Figure 2.25). We were not aware of any water ingress concerns related to the skylights. We did not review a skylight at Building B as there were no skylights opened at the time of the review.

Figure 2.24
Stained wood framing at a skylight.
Building A.

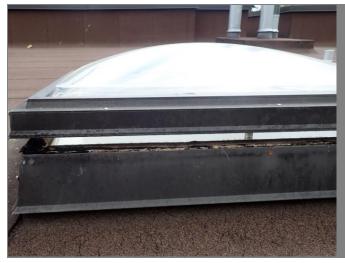
Figure 2.25
Stained wood framing at a skylight.
Building C.

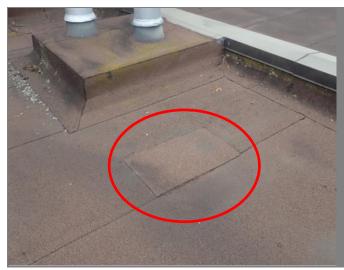
→ There was evidence of localized repairs in the SBS membrane at some locations (Figure 2.26 to Figure 2.28).

Figure 2.26
Example of a localized repair in the SBS membrane.
Building A.

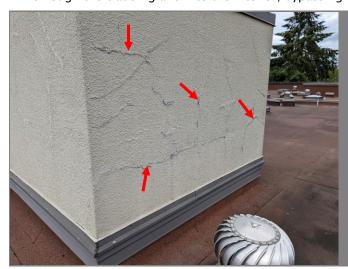
→ There were unsealed cracks in the stucco cladding on the elevator shaft overruns, particularly at Building A (Figure 2.29). Unsealed cracks could allow water to penetrate through the cladding and into the interior, bypassing the SBS membrane.

Figure 2.29
Cracks in the stucco cladding at the elevator shaft overrun of Building A.

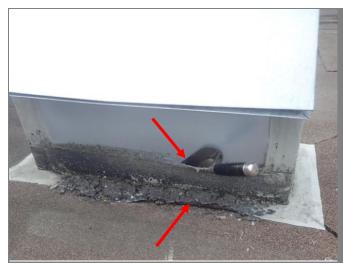
Figure 2.33

→ There was liquid-applied membrane installed adjacent to the renewed vent hoods. At several areas reviewed, the liquid-applied membrane was delaminating from the substrate (Figure 2.32 and Figure 2.33). At one location, there was water between the liquid membrane and the vertical metal surface of the vent hood (Figure 2.34).

Example of delaminated liquid-applied membrane on the SBS membrane and the vent hood.

In the near future, the Owners should implement targeted repairs to address the localized issues, such as delaminated membrane, failed sealant, and dropped concrete tiles. Furthermore, the Owners should continue to implement maintenance activities to address debris buildup on the low-slope roofs, such as near drains. These items can be completed by a competent roofing contractor. Given the financial impacts associated with future renewals, the Owners should also begin to plan for a low-slope roof and slope roof renewal project.

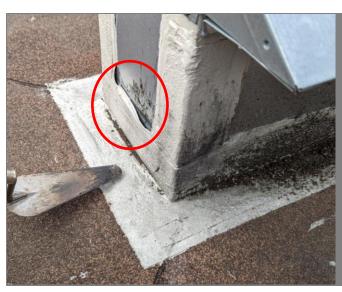
Figure 2.34
Water behind the liquidapplied membrane at a vent
hood.

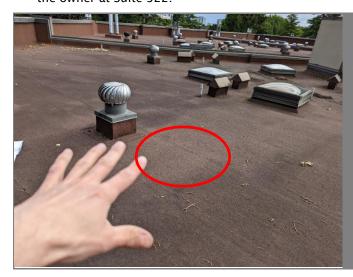
→ RDH reviewed the roof area above the reported leak at Suite 322 (Section 2.1). We did not note roof deficiencies above the reported stain on the living room ceiling (Figure 2.36). In addition, there were no obvious signs of recent repairs as was reported by the owner at Suite 322.

Figure 2.36
Approximate roof area above the reported stain on the ceiling of Suite 322.

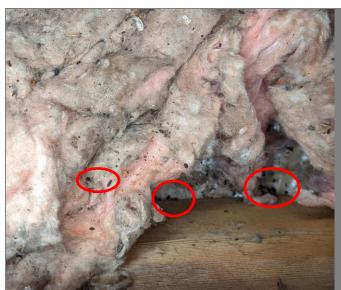
Figure 2.37

→ A turbine vent was temporarily removed to review concealed conditions. The observed components were consistent with the assembly listed in Section 1.2.1. Note that there was what appeared to be animal debris, such as mouse droppings, within the batt insulation and on the polyethylene vapour barrier (Figure 2.37).

Looking down into the lowslope roof assembly where the turbine vent was temporarily removed at Building B.

Note the animal feces.

There may also be an opportunity for the Owners to improve the thermal performance of the low-slope roof assembly at the time of renewal, which could improve occupant comfort on warmer days. This would require further review and discussion to determine feasibility and possible benefits. Replacing the batt insulation and removing animal feces would likely be included if thermal performance upgrades are implemented.
