## **Roof Evaluation Report**

| <b>Project</b> | NW 2050 Cypress Point | <b>Date</b> | May 7, 2024 | <b>Job Number</b> | 24064 |
| <b>Address</b> | 7511, 7531 & 7651<br>Minoru Boulevard,<br>Richmond, B.C. | <b>Inspector</b> | Ted Neef | <b>Weather</b> | Sun/12°C |

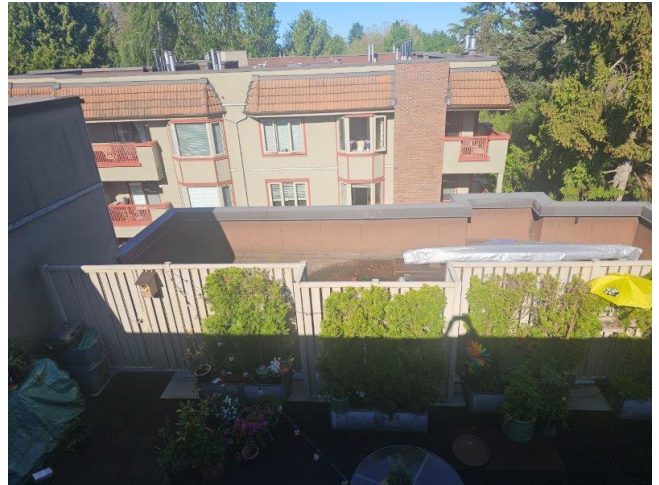
1. A view of the roofs being inspected for reference purposes only. There is a main upper flat roof, lower roofs over living space (some of which are also roof decks for the owners) as well as a lightweight concrete tile on the steep slope outer roofs.

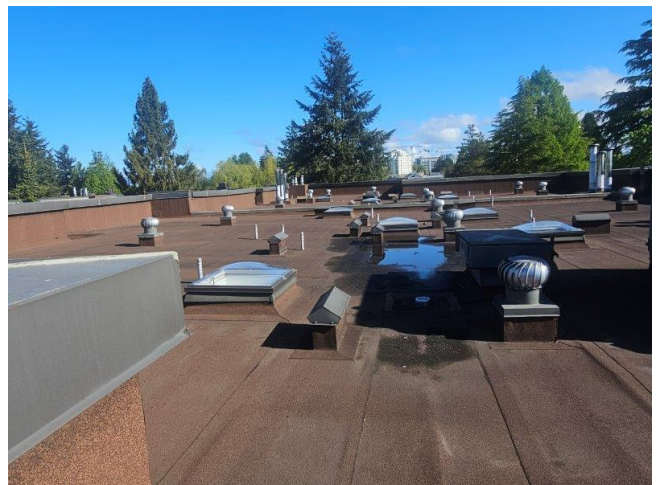
2. The flat roofs have a 2 ply SBS system installed. These roofs drain towards the center due to a built-in slope.

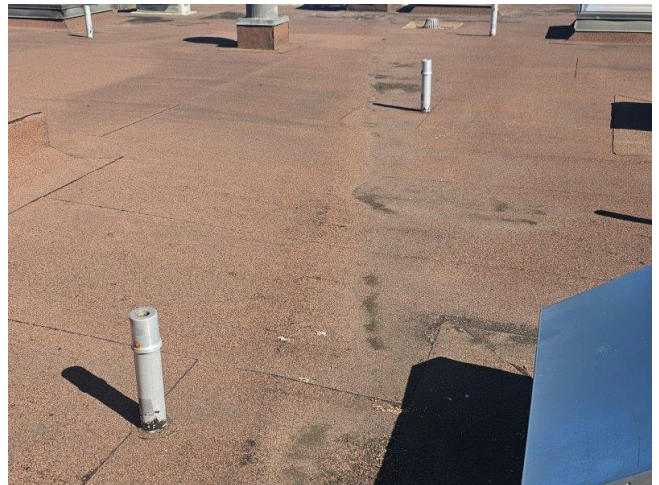
3. Large crickets were installed between the drains and between the drains and the end walls to help move water out of the common valley on building B. The other two buildings lack these crickets.

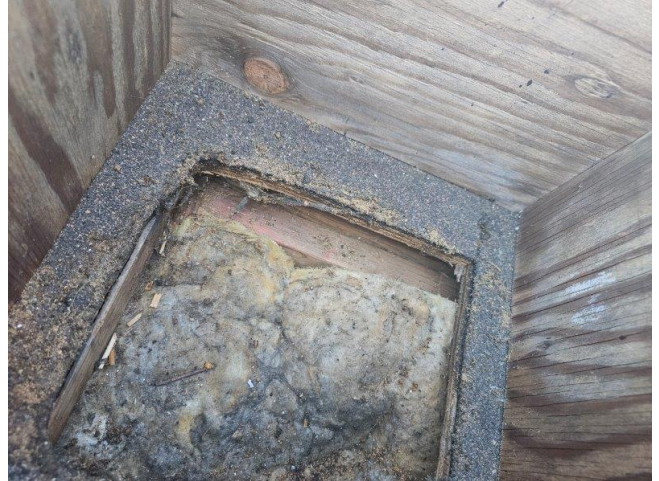
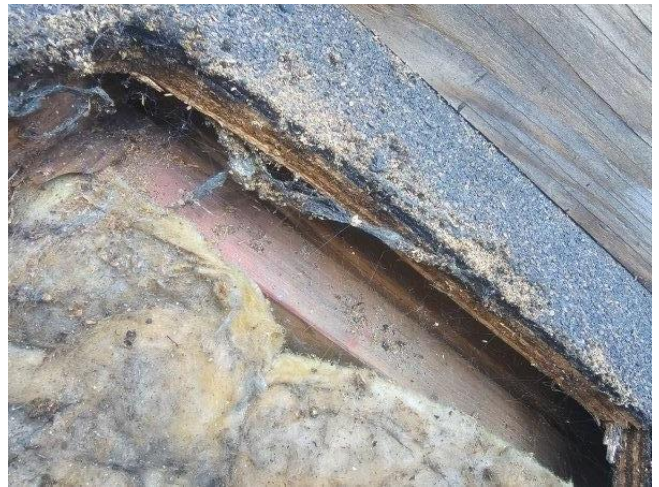
4. Vent hoods were removed to determine the roof make up. At all locations on all buildings a 2 ply SBS torched directly to the 5/8" plywood deck was noted. The roof trusses were cross strapped to provide air movement, though the space between the top of the insulation and the underside of the roof deck is small; 2" or less.

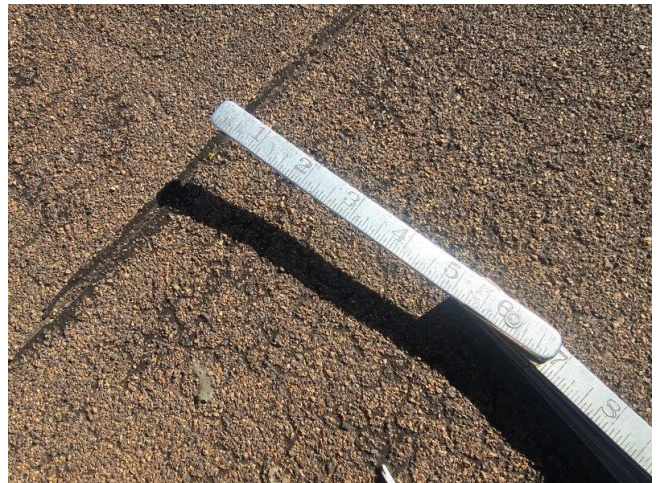
5. The quality of the membrane installation varies. In some locations there is the proper overlap at the end of the rolls while in other locations there isn't. Some corners are cut as required and some are not. Pictured here is an overlap of 4" when the manufacturer requires 6".

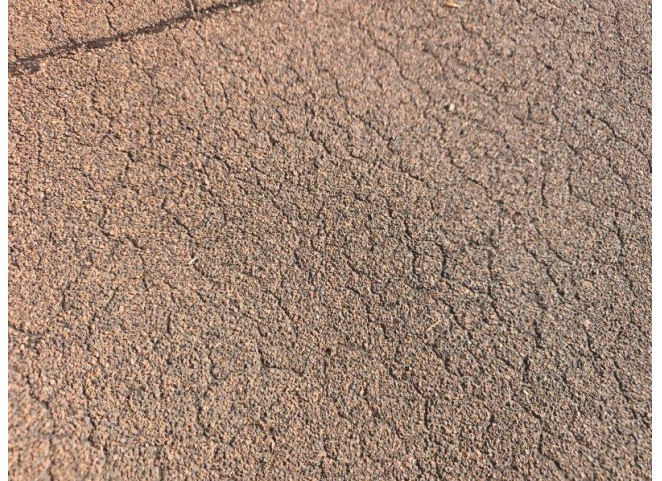
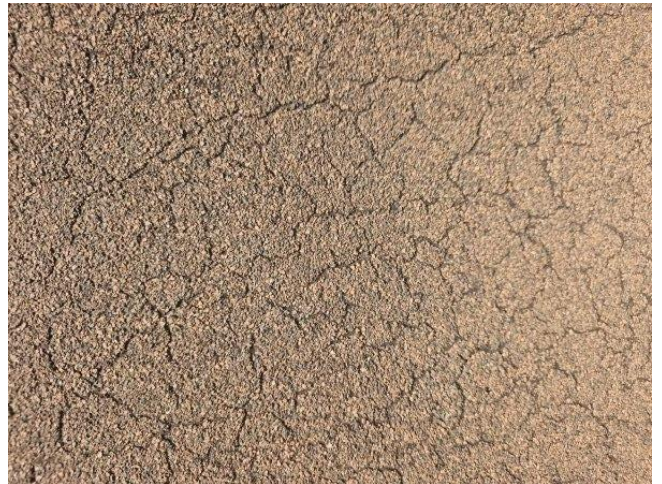
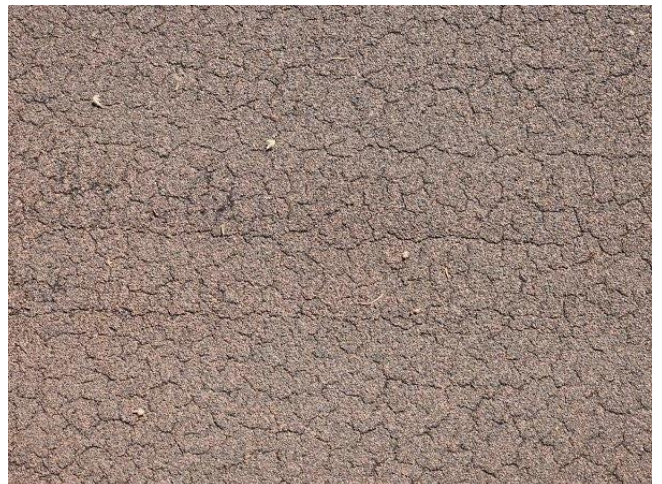
6. The top surface of much of the membrane has developed cracks throughout. The top layer of the modified asphalt is failing.

It should be noted that all three buildings are represented in this photo.

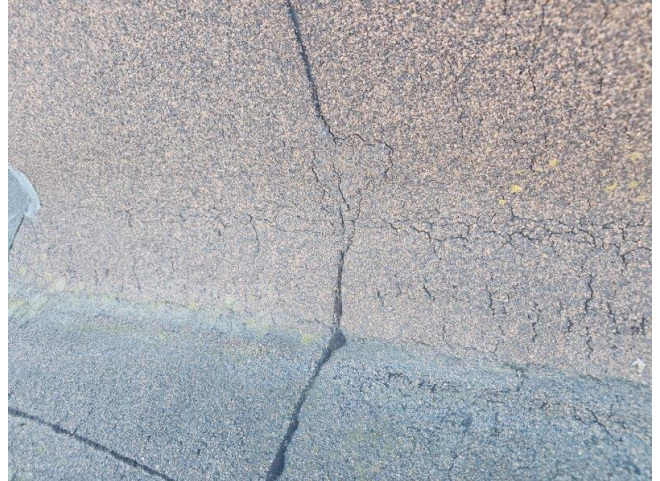
7. These cracks are occurring not only in the field but the perimeter stripping as well, particularly on the North and East sides that receive the Sun.

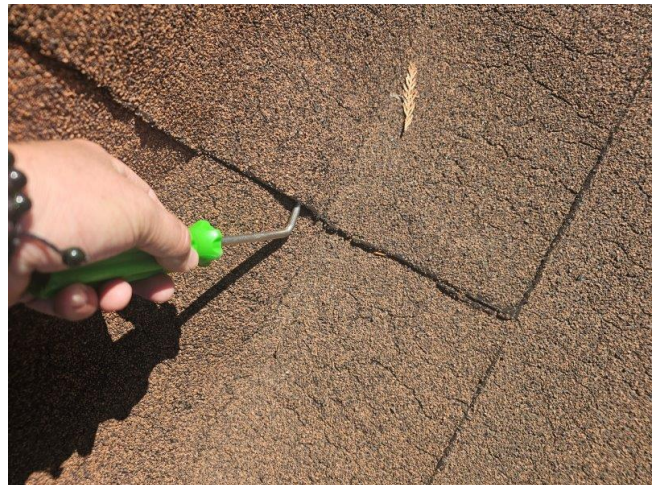
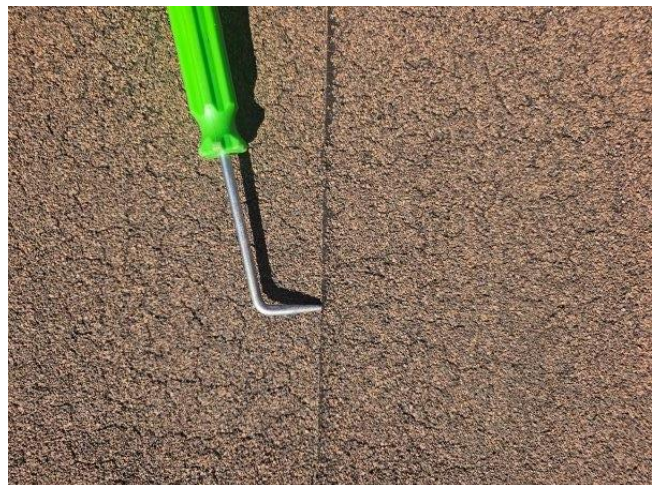
8. Partially open seams were noted in the field membrane. Over time, water will infiltrate the seams, forcing them open further when the water freezes over the winter months. This freeze/thaw cycle will occur many times throughout the year.

Asphaltic bleed out is required by all membrane manufacturers which will help keep the seams sealed. The bleed out at the edges of the membrane is very inconsistent on all roofs.

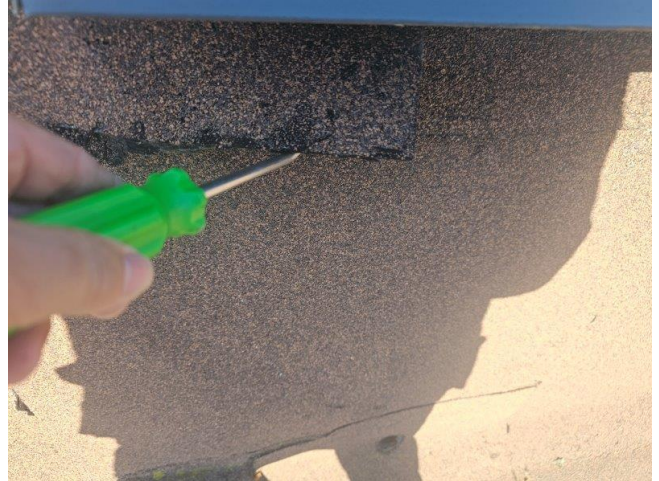
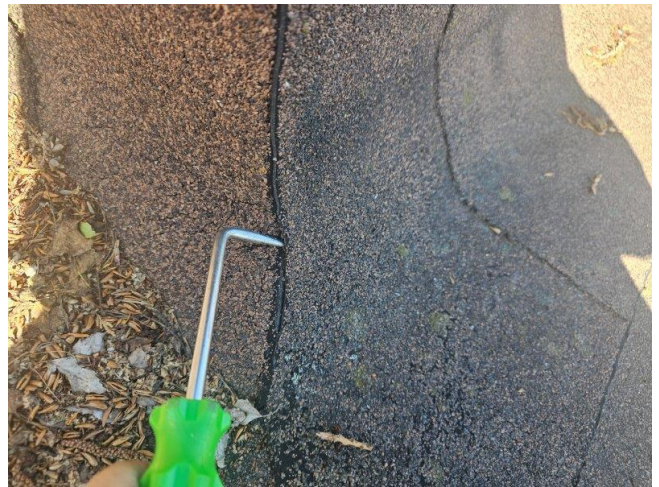
9. Partially open seams were also discovered in many of the stripping plies at the perimeter or at the base of curbs.

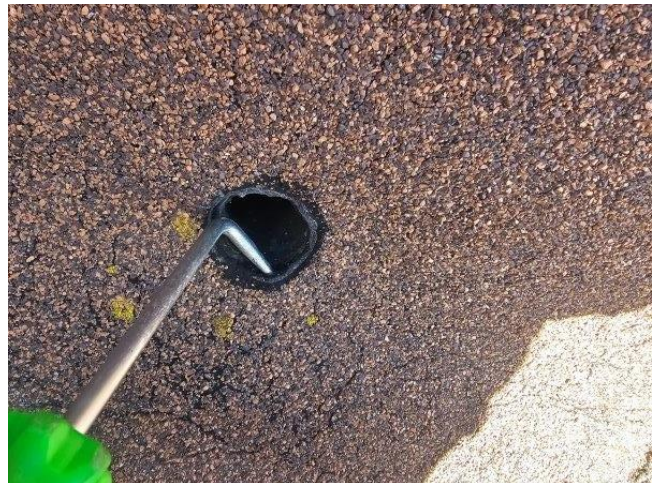
10. The membrane bond at some of the overflows is also failing.

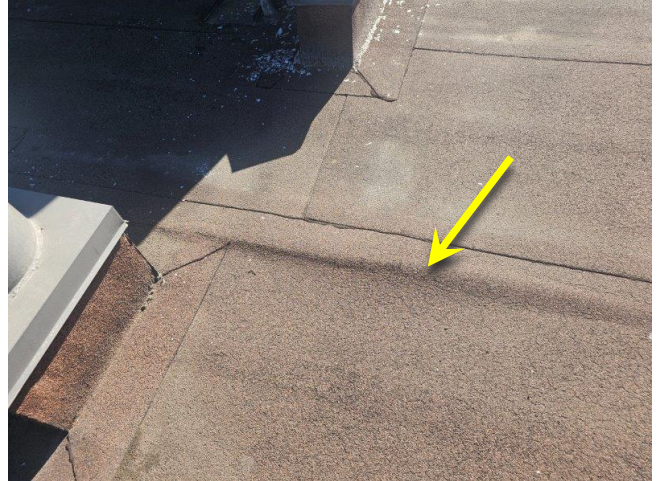
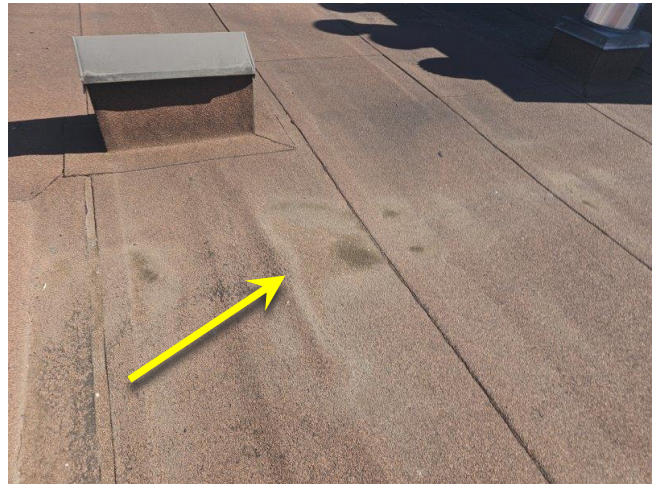
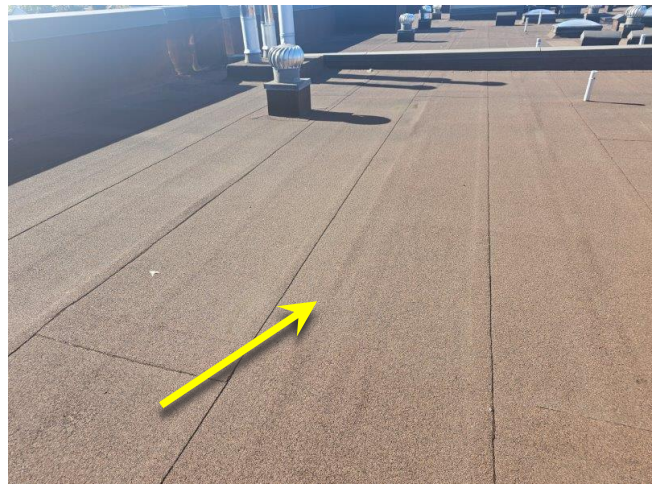
11. Large buckles were noted throughout the roof area. These buckles are usually a result of poor adhesion between the layers of the membrane. Movement in the roof deck can also cause the membrane to develop buckles. The buckles will pull at the seams, causing them to eventually separate.

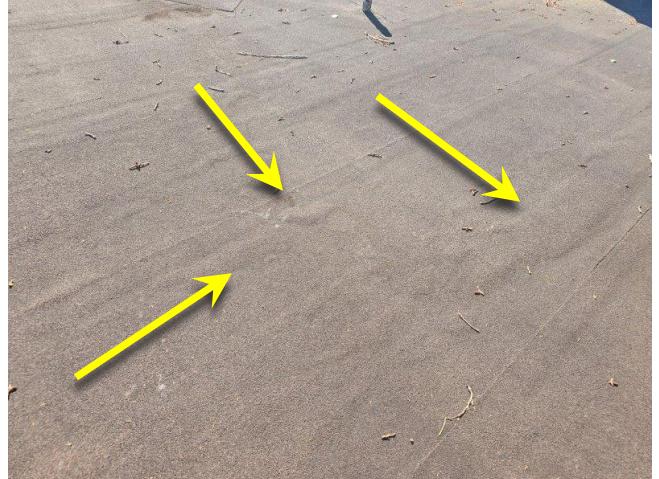
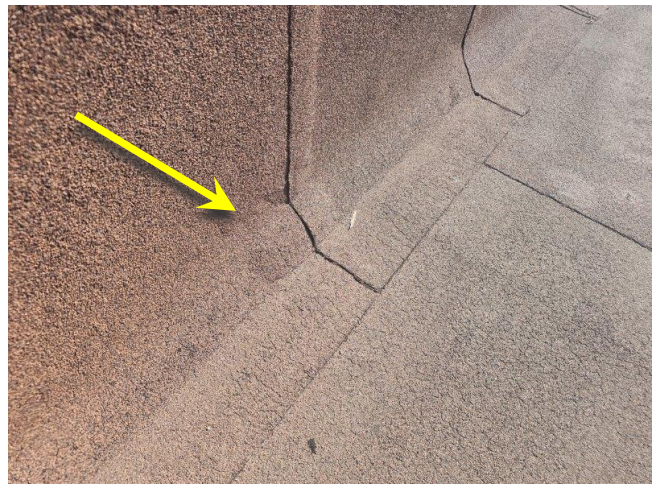
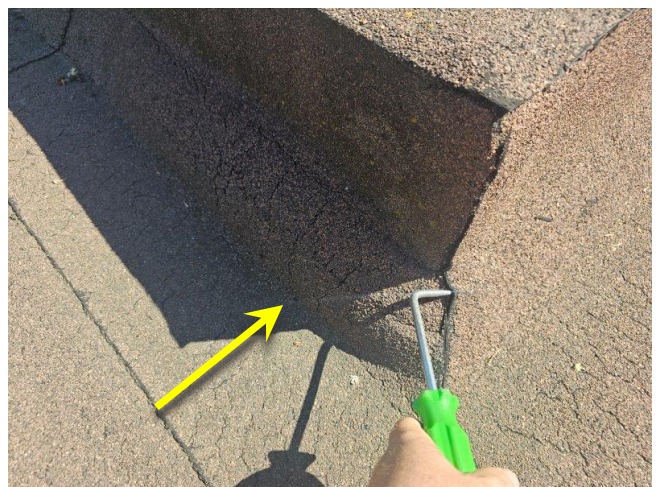
12. Blisters were noted, ranging in size and shape from small to very large. Some could be a result of water leaks though the majority are a result of a poor bond between the layers. On a hot day, we would expect to find more blisters as they have a tendency to puff up when heated.

The blistering is the worst on Building C.

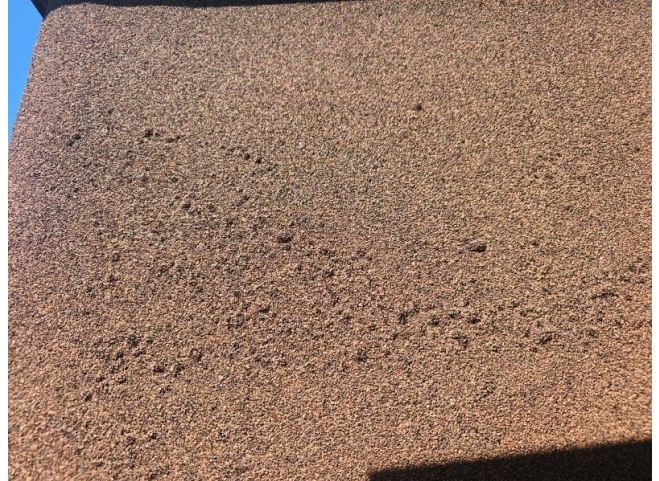
13. Small blisters were also discovered in areas. These are a result of a manufacturing defect. Fortunately, they occur on the walls, well above the water level if the drains were plugged.

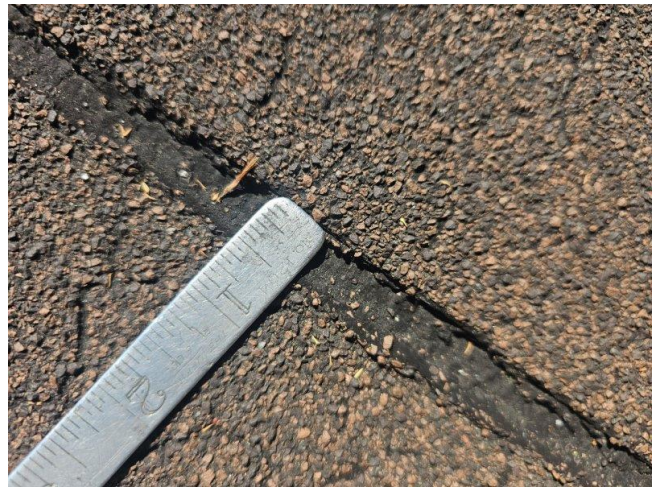
14. As the roof membrane ages, it will start to shrink. Here we can see that the end laps are pulling apart. In many areas the membrane has slid apart as much as 1". This number is one of the many indicators that we use to determine remaining service life.

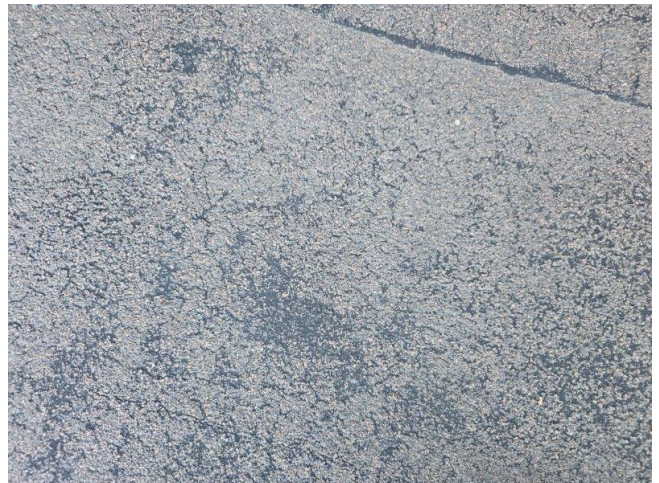
15. Granule loss is occurring in areas, particularly where water is dropping from the parapets back onto the roof or in areas that experience a higher flow of water. Granule loss is part of the natural aging process of the membrane.

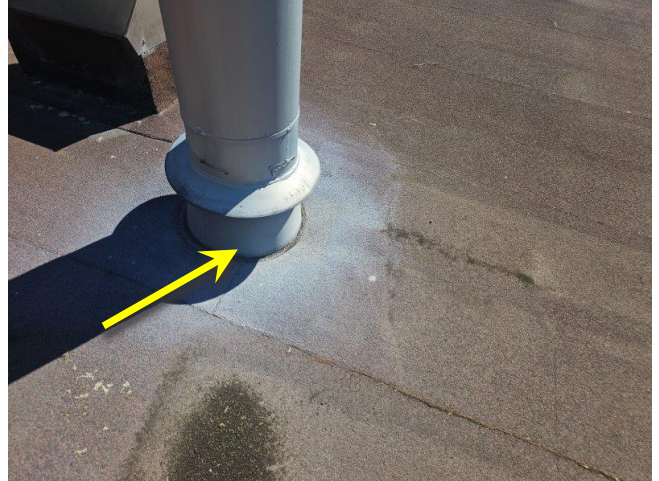
16. The membrane seal at the base of stacks and vents is starting to break down in areas, which will allow water to leak in between the SBS and the penetration. Asphaltic mastic was used at these locations, which will break down over time. Modern sealants have replaced this product and are nearly maintenance free for the life of the roof.

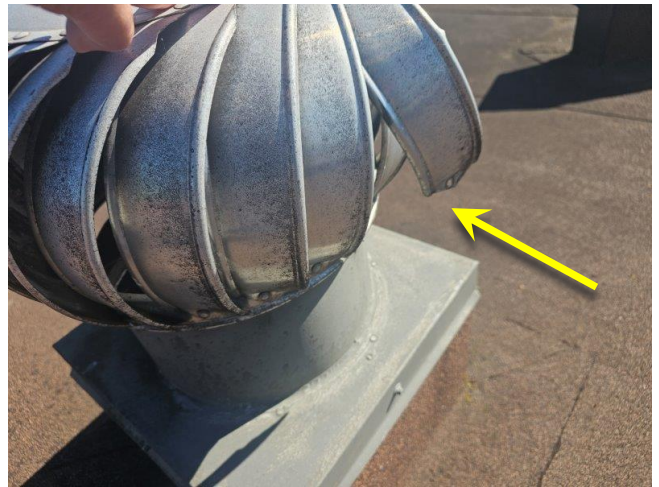
17. Turbine vents were installed on the flat roofs. Some of the vents are noisy as the bearings have worn out while others are falling apart. Turbine vents are typically not used on flat roofs.

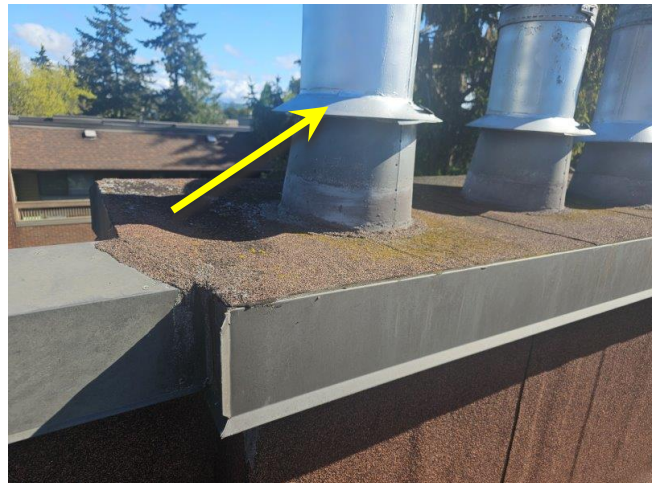
18. The caulking at the B-vent storm collars on both the single pipes and chimney caps is still in fair condition and appears to have been well maintained.

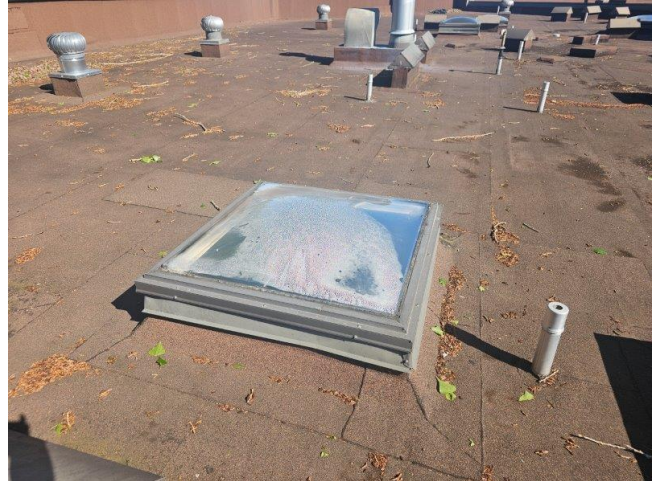
19. Condensation was noted on some of the skylights.

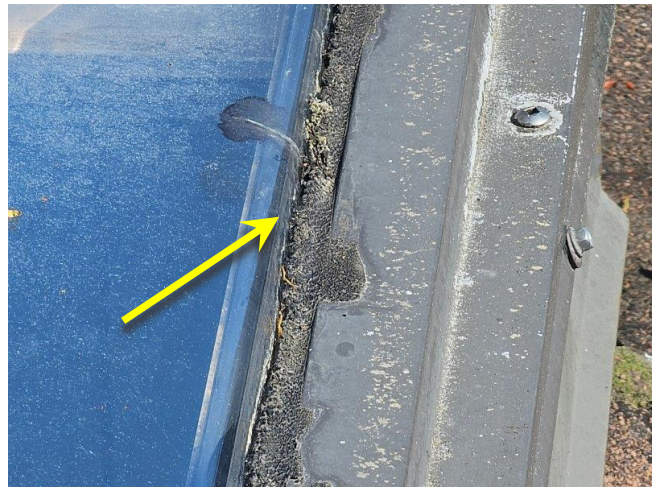
20. Over time, the seal between the plastic bubbles will fail, which can cause condensation. This skylight has been re-caulked at one time. It should be noted that this style of skylight is not energy efficient and is prone to air leakage.

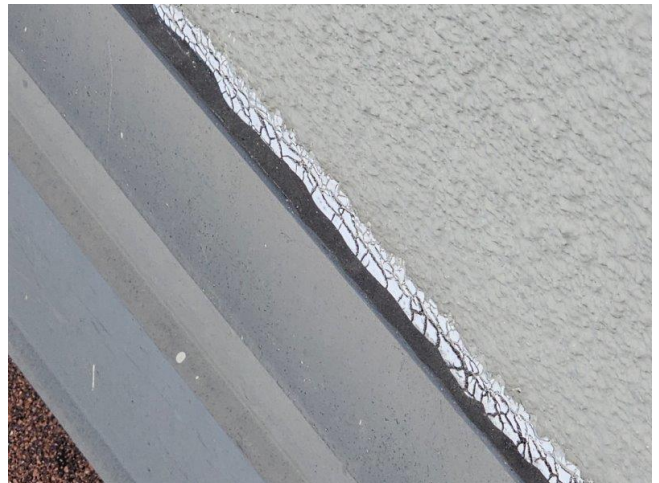
21. Caulking at the gum lip flashing at the elevator room walls is breaking down. All exterior caulking, particularly at the roof level needs to be periodically re-applied.

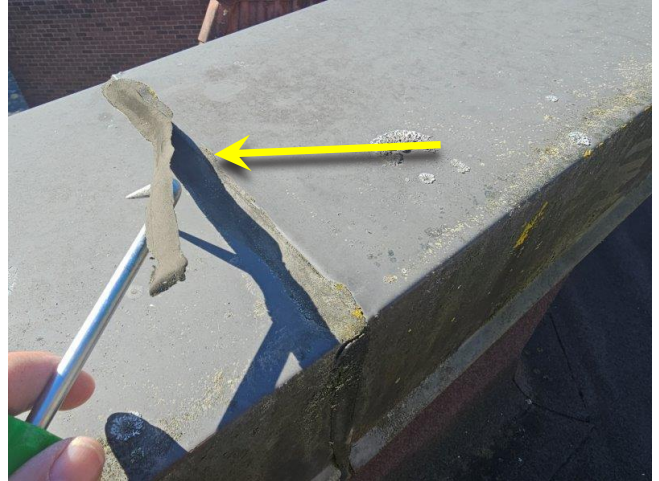
22. The caulking at the flashing joints is starting to fail. This is a maintenance item.

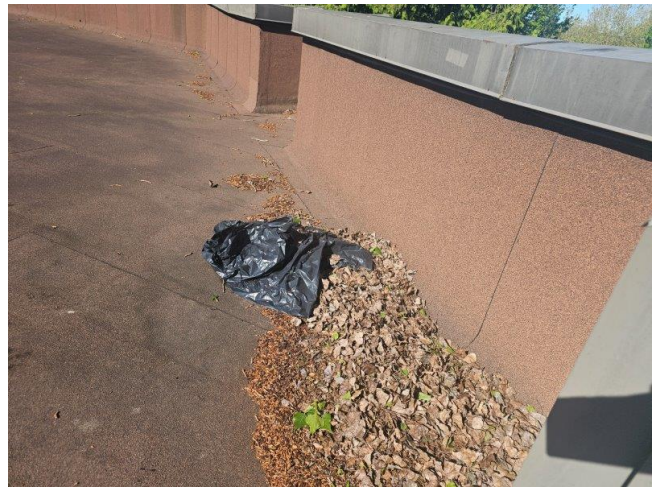
23. Debris is accumulating on areas of the flat roof, particularly along the West end of the complex.

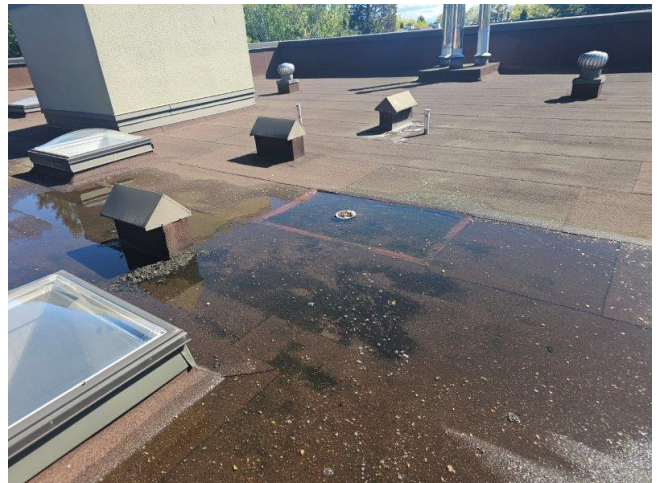
24. One drain was noted to be blocked with debris on Block C.

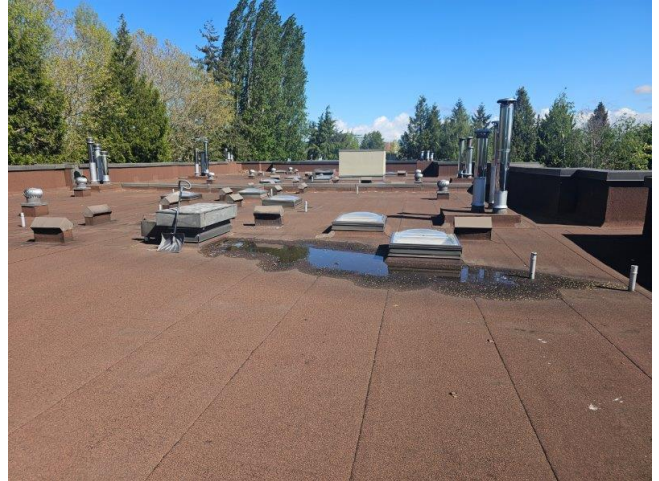
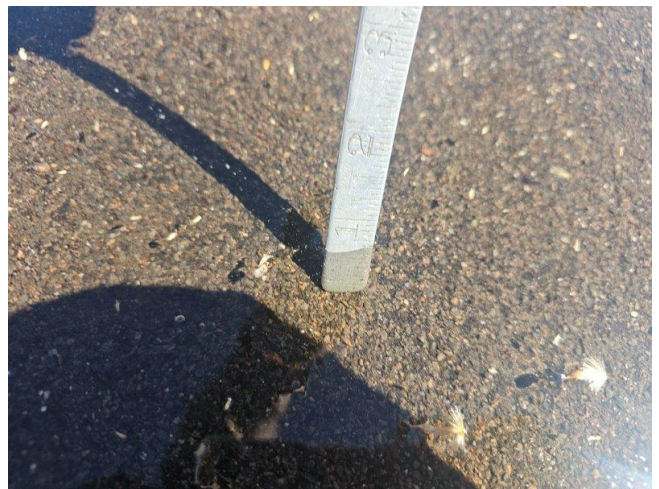
25. As noted previously, large crickets were installed between the drains on the one building only. Unfortunately, they were not designed correctly resulting in water pooling before the drains. Some standing water can be expected, though it shouldn't be a large amount. When the membrane is replaced, these crickets will need to be redesigned and should be added to the other two buildings.

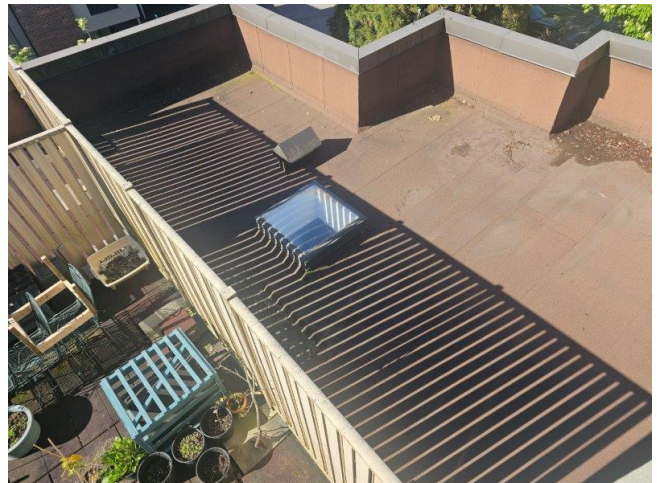
26. Complicating the future roof membrane replacement are the lower flat roofs that are over living space and extend under the decks of some of the owners. We know that SBS will last longer if protected from the Sun (such as hidden under deck boards). However, when the membrane is only partially protected, the entire membrane over the roof area will require replacement. The condition of the exposed membrane is similar to what is found on the upper roof of all three buildings.

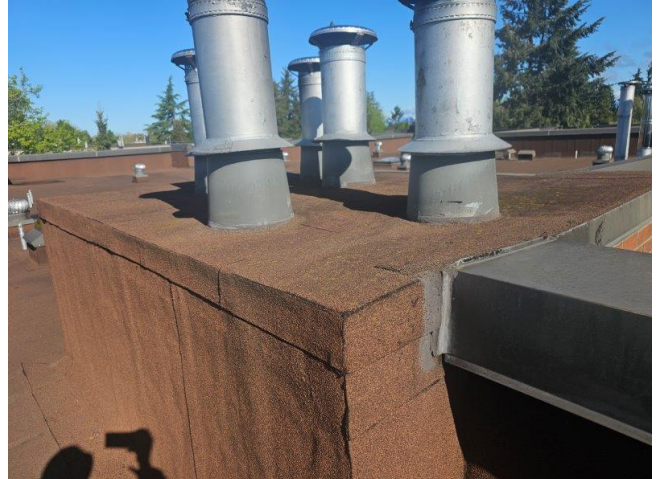
27. The tall chimneys do not have a traditional metal cap installed, instead the top was covered with SBS along with the corresponding B-vent flashings. This is a non-typical installation.

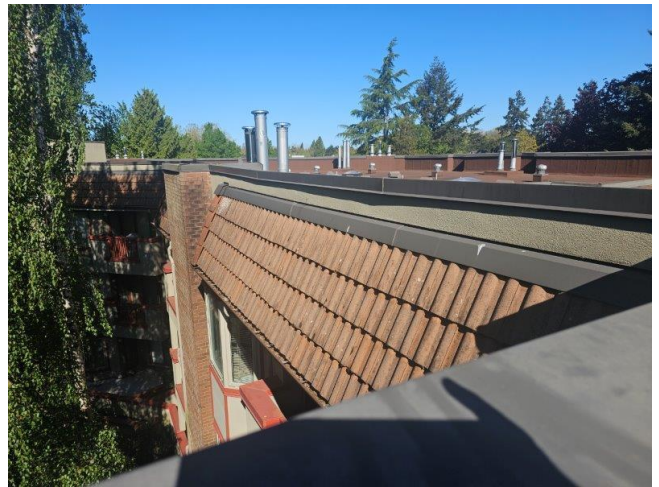
28. Lightweight concrete tiles are installed to the slope roofs. These roofs are what are known as a mansard style roof and are closer to a wall than a typical roof.

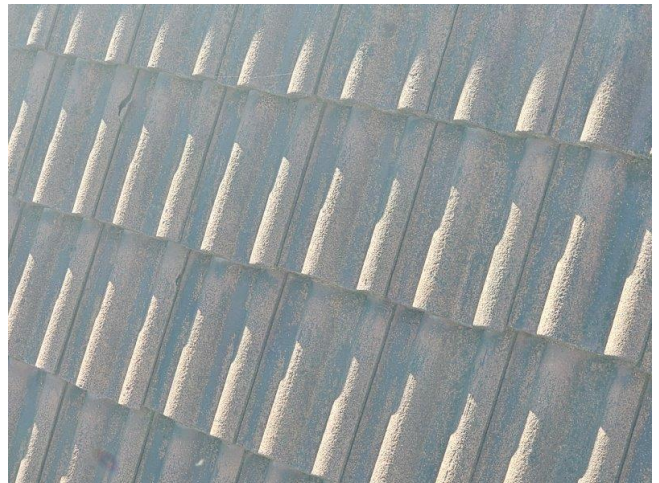
29. The extreme steep slope will extend the life of the roofing material as water will run off quickly, debris will not accumulate, nor will most snow.

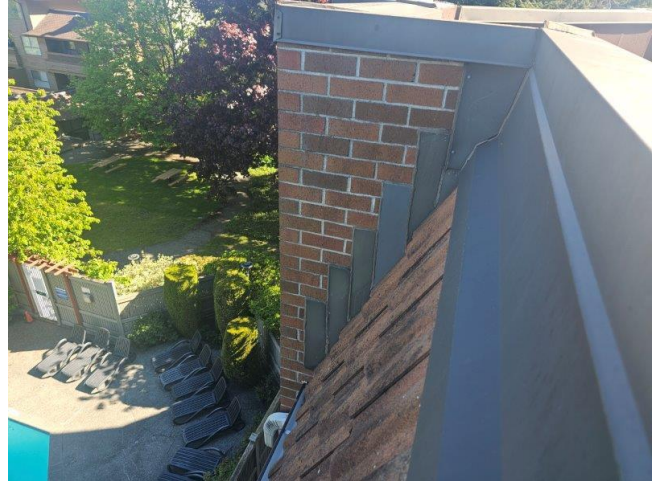
30. Some areas that will require maintenance are the caulking in the flashing joints against the brick walls. However, most of this caulking is well shaded and is still in fair condition where observed.

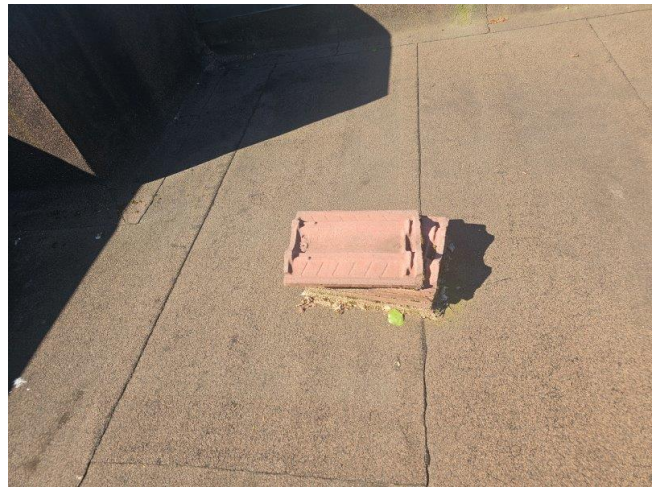
31. A few spare tiles were noted on Building B- these should not be disposed of when the flat roof system is replaced as lightweight concrete tiles are no longer manufactured or stocked locally.

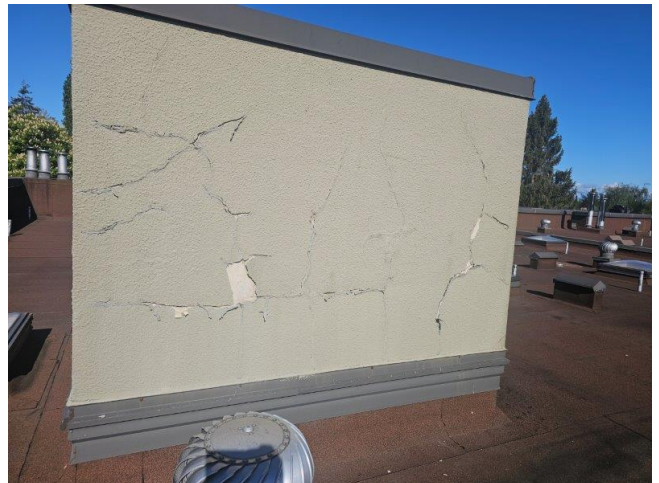
32. Though not roof related, the coating on the exterior wall of the elevator shaft is heavily deteriorated.
