Installation Monitoring Report

Project	NW 2050 Cypress Point	Job Number	24064 RGC Number		lumber	53216	
Address	7511, 7531, 7651 Minoru Boulevard	Inspector	Matthew	Report Number		23	
	Richmond, B.C.	Weather	Sun / 26°C	Time		12:00pm	
Contractor	Flynn Canada Ltd.	Crew Size	22 Red Sea	l 6	Apprentices 13		13

Date: July 8, 2025

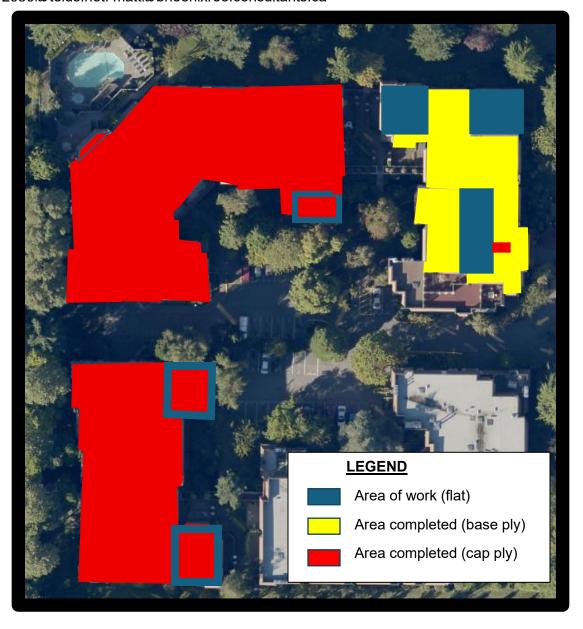
23.1 **Building B**

Base wall flashing has begun to be installed on the East deck location.
