To The Owners, Strata Plan NW2050 c/o Audrey Montero, Strata Office Administrator Cypress Point - Strata Plan NW2050 7651 Minoru Boulevard Richmond BC V6Y 1Z3

Site Visit: March 31, 2021 Submitted December 15, 2021 by RDH Building Science Inc. 4333 Still Creek Drive #400 Burnaby BC V5C 6S6

RDH Building Science Inc. (RDH) was retained by the Owners, Strata Plan NW2050 (Owners) to prepare a Depreciation Report Update (Report) for the residential complex known as Cypress Point, which is located at 7511, 7531, and 7651 Minoru Boulevard, Richmond, BC. The Report considers the common property and limited common property components (the Assets) that the Strata Corporation is responsible to maintain, repair, and replace.

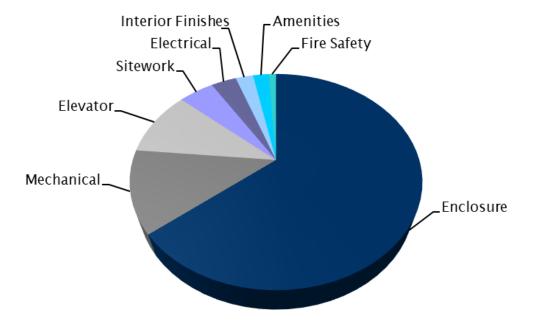
Figure 4.1 Distribution of estimated capital expenditures over 10 years by system.

Approximately 40% of the Strata Corporation's capital expenditures may occur in the next 10 years. The distribution of estimated capital expenditures over the next 10 years is shown in Figure 4.1 below.

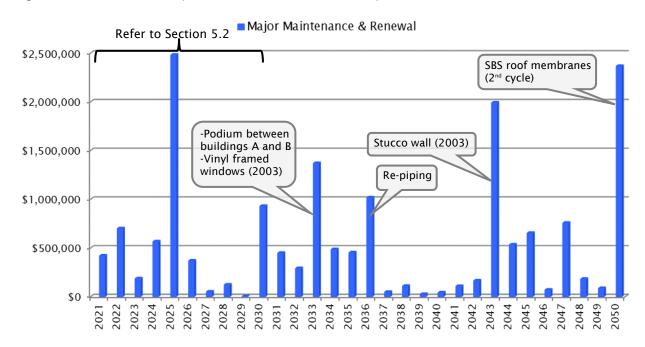
Figure 5.1 Strategic Forecast (30 Years), showing the approximate timing and value of some key capital expenditures.

Estimated major maintenance and renewal costs over the next 30 years are shown on the graph below (Figure 5.1). The blue bars represent the estimated value of capital costs.

Each bar on the graph represents a collection of different major maintenance and renewal activities, each with different values. Detailed information about each year, including a description of the maintenance and renewal activities and estimated costs, is available in the appendices.

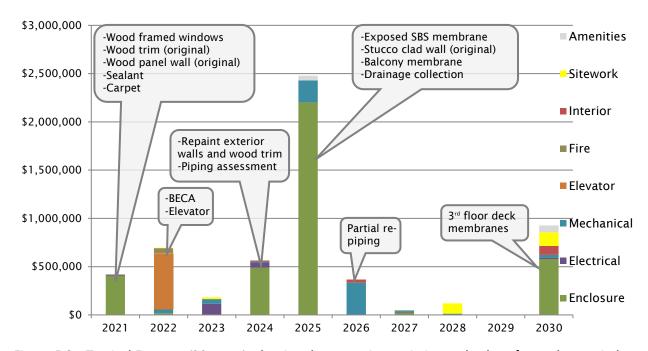
Figure 5.2 Tactical Forecast (10 years), showing the approximate timing and value of some key capital expenditures.

The graph below shows the projected major maintenance and renewal costs for the next ten years (Figure 5.2). Commonly, building managers refer to a five-year tactical plan; however, a ten-year plan allows the Strata Corporation to see a wider range of projects.

The bars indicate the years in which an event (or bundle of events) is most likely to occur as well as the total magnitude of major maintenance and renewal costs for that year and the costs broken down by system. The costs associated to correct any warranty defects are not included. The soft costs associated with project implementation, such as site access, design, contract administration, are not included.

The tactical plan above represents one of many possible approaches to planning major maintenance and renewal activities. The Strata Corporation can use this initial plan as a tool, a starting point to identify probable projects, priorities, and strategies. The actual cost, timing, and scope of projects will be determined by the Strata Corporation and may be reflected in updates to the Depreciation Report Update.

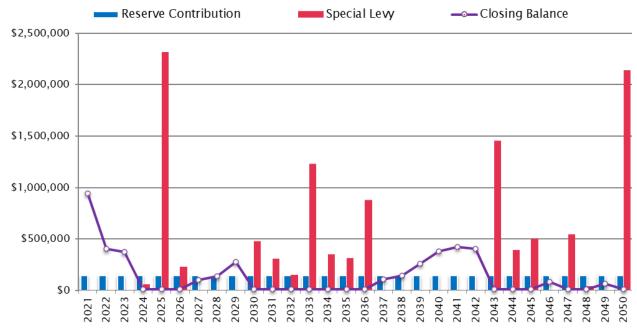
Figure 6.1 CRF balance, contribution and special levies based on the current funding.

The graph below shows the annual contribution to the CRF, the closing balance of the CRF, and the size of the special levies forecast for the next 30 years.

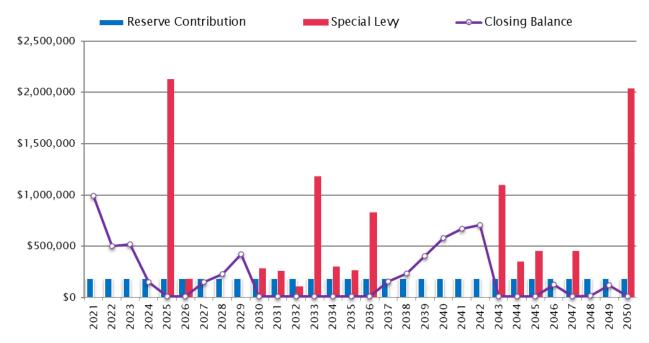
Figure 6.2 CRF balance, contribution and special levies based on Alternative #1.

Alternative funding scenario #1 eliminates some of the smaller levies, but it is not adequate to offset all the special levies over the 30-year planning horizon. The graph below shows the annual contribution to the CRF, the closing balance of the CRF, and the size of the special levies forecast for the next 30 years.

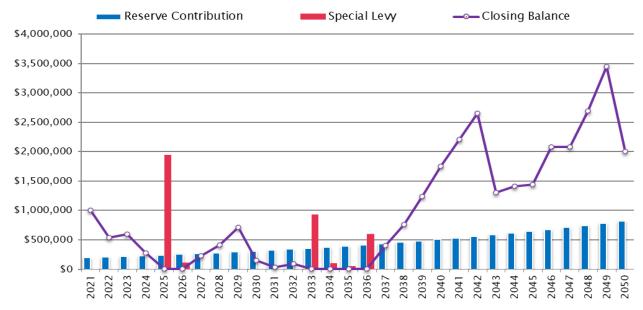
Figure 6.3 CRF balance, contribution and special levies based on Alternative #2.

Alternative funding scenario #2 further eliminates some of the smaller levies, but it is not adequate to offset all the special levies over the 30-year planning horizon. The graph below shows the annual contribution to the CRF, the closing balance of the CRF, and the size of the special levies forecast for the next 30 years.

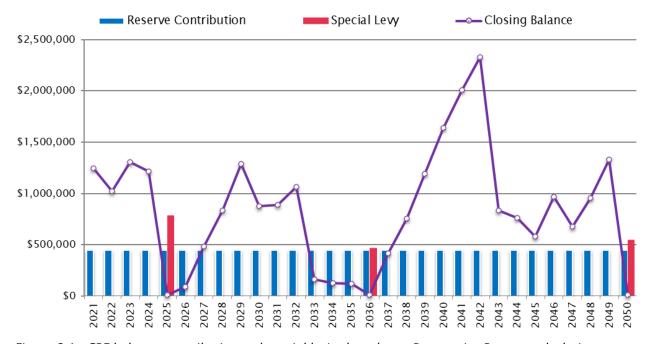
Figure 6.4 CRF balance, contribution and special levies based on a Progressive Reserve calculation.

The Progressive Reserve would offset smaller special levies. However, because of the timing of anticipated renewal projects, a fixed annual contribution will not eliminate all special levies over the 30-year planning horizon. The graph below shows the annual contribution to the CRF, the closing balance of the CRF, and the size of the special levies forecast for the next 30 years.
