R-02574.062 Cypress Point | Roof Assessment

REGARDING Roof Assessment

As requested by the Owners, Strata Plan NW2050 (Owners), RDH Building Science Inc. (RDH) is pleased to provide you with this report for a roof assessment for the complex known as Cypress Point, located at 7511, 7531, and 7651 Minoru Boulevard, Richmond, BC.

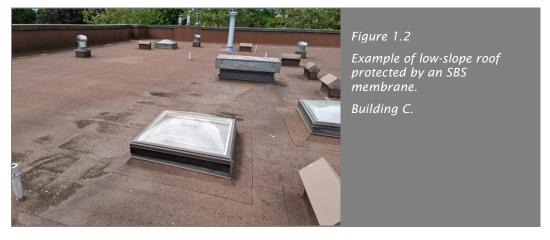
Figure 1.3

There are two principal roof assemblies at the buildings: low-slope roofs protected by 2-ply styrene-butadiene-styrene roof membranes (SBS membrane, Figure 1.2) and sloped roofs protected by concrete tiles (Figure 1.3).

Example of a sloped roof protected by concrete tiles.

Building B.

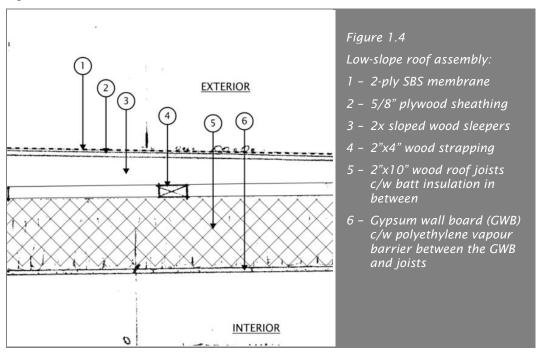
The original architectural drawings indicate that the low-slope roofs were originally constructed with tar and gravel membranes (page A31). It is our understanding that these low-slope roof membranes were replaced with SBS membranes in approximately 2000. The current assembly, as noted on site and from architectural drawing A31, is listed in Figure 1.4.

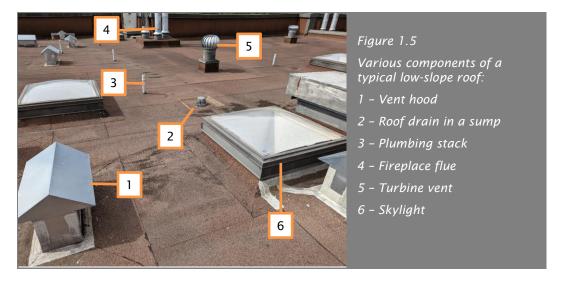
As the name implies, a 2-ply SBS membrane is composed of two plies of membrane: a base sheet and a cap sheet. The low-slope roof is sloped to roof drains, located in sumps or depressions, which are connected to internal drain pipes. In addition, there are overflow scupper drains at the perimeter parapets. There are unit skylights throughout the roofs. Vent hoods (sometimes referred to as dog houses) protect exhaust vents, such as for laundry dryers. In addition, there are plumbing stacks and fireplace flues throughout the roofs. Refer to Figure 1.5 for examples of various low-slope roof components.

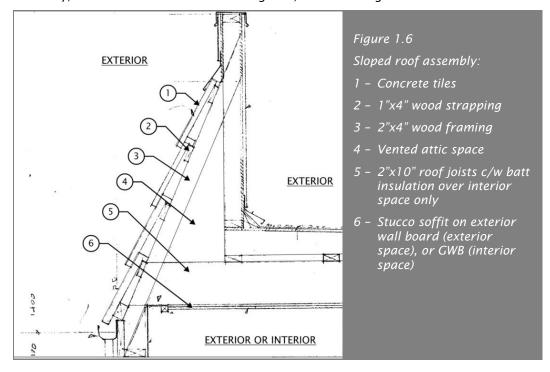
The concrete tiles at sloped roofs appeared to date from original construction. The assembly, taken from architectural drawing A31, is listed in Figure 1.6.
